Machinery MESsages

THE DYNAMICS OF A VERTICAL PUMP

By Tom Spettel
Customer Training Manager

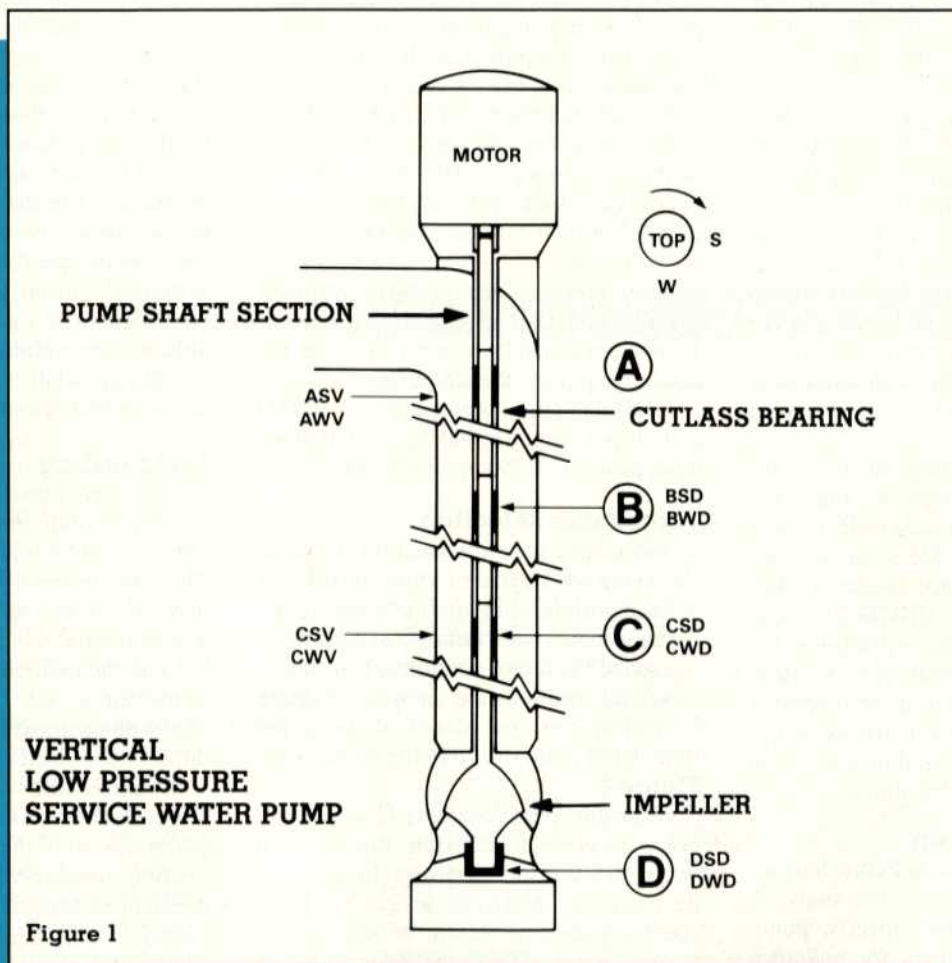
A drawing of the pump and motor is shown in Figure 1.

Since very little information is available on the rotor dynamic characteristics of vertical pumps, both proximity and velocity transducers were installed at each bearing and at the motor coupling. Transducer mounting locations are shown in Figure 1. Transducers are identified using the three-letter code shown in the legend with Figure 1.

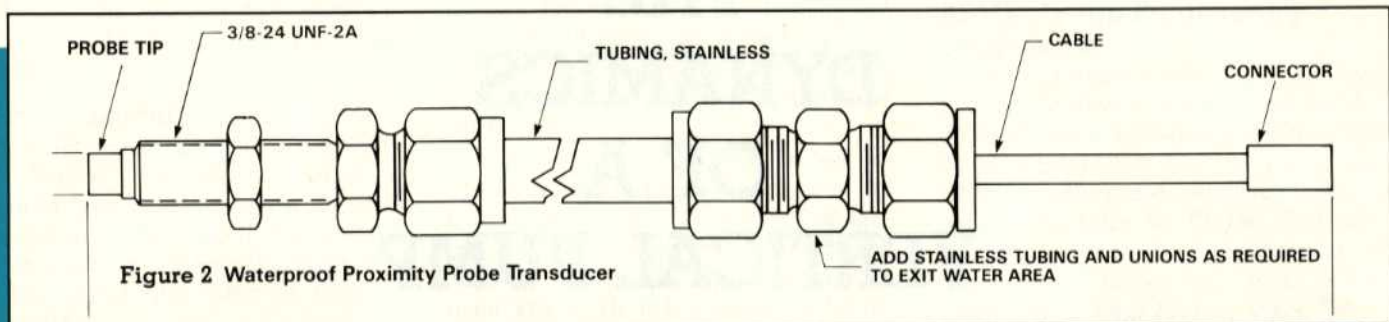
Figure 2 Waterproof Proximity Probe Transducer

Transducers at locations C and D are below river level, dictating the use of a waterproof transducer design. In addition, the transducer had to be designed to withstand the abrasive action of sand in the flowing water. The probe design used is shown in Figure 2.

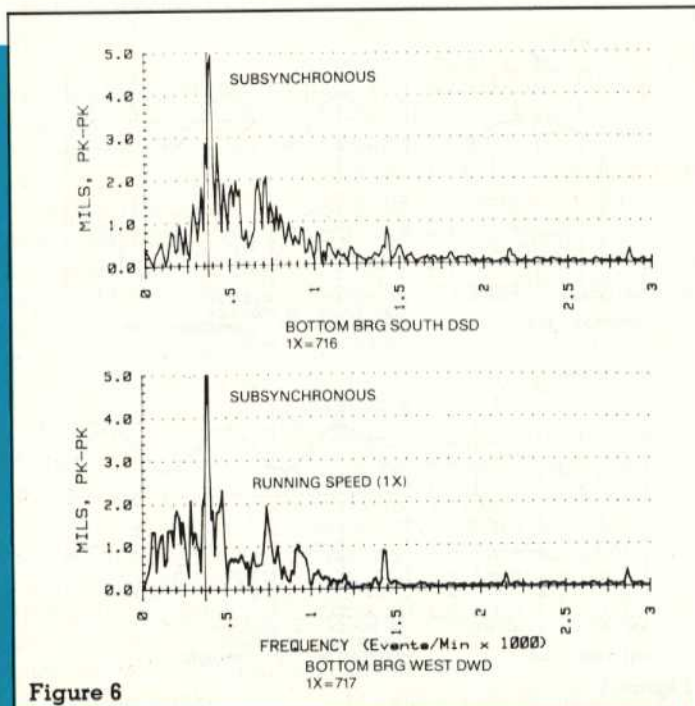
Figure 6

With design clearance, spectrum plots of shaft vibration data from the lower bearing show strong subsynchronous response at 372 cycles per minute (**Figure 6**). This frequency is the first bending natural frequency (critical) of the pump shaft. When the clearance was increased, the subsynchronous vibration became less stable and occurred over a broader frequency range.

The hydraulic response testing determined that the re-excitation of the first balance resonance by the subsynchronous vibration was the cause of the recent shaft failures. These failures were identified by metallurgical analysis as bending fatigue failures.

The answer to these questions was discovered by researching the maintenance records. It was found that the start of shaft failures was preceded by a change in impeller supplier. Recent impellers were not purchased from the original equipment manufacturer (OEM), but from another vendor. The OEM has since indicated that subtle changes in the blade attack angle could cause the re-excitation of the first bending natural frequency (critical) due to vortex shedding.
