# Cracked Bearing Race Detection in Wind Turbine Gearboxes

[Note: This article is based on a paper presented at the China Wind Power 2010 conference in Beijing, China in October 2010.]

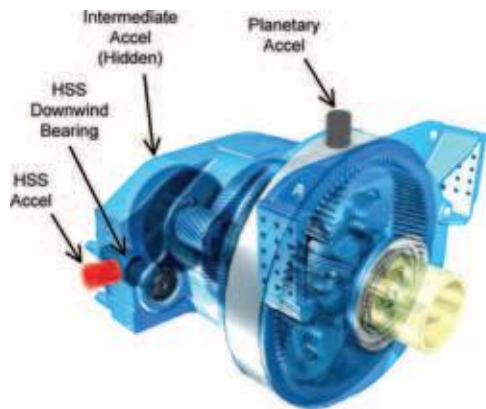
**Figure 1:** Wind turbine gearbox, viewed from the main rotor side. The high-speed shaft downwind bearing (HSS DW) and accel locations are shown. The high-speed accel location used for this case history is shown in red.

In this case history, we will be discussing enveloped data from the gearbox high-speed shaft (HSS) accel (Figure 1). The diagnostic process utilized the high sensitivity provided by acceleration enveloping, so we will begin with a brief review of the enveloping process.

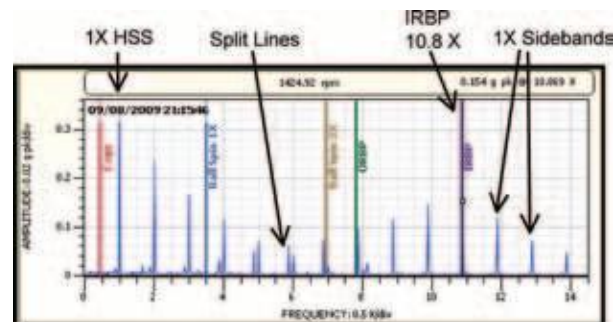
**Figure 4:** Acceleration envelope spectrum of waveform in Figure 2 (September 2009). The key bearing fault frequency lines are overlaid on the plot. The IRPB fault line is a perfect fit to the data. The split lines show that the two harmonic series are separated. Data processed in ADAPT.wind software.

Enveloped spectra from this accelerometer display a rich harmonic series (Figure 4). This figure shows enveloped frequencies in orders of high-speed shaft (HSS) speed. The lowest fundamental corresponds to the HSS speed (1X HSS), and there are several harmonics. The next major feature is the inner-race ball pass (IRBP) frequency at 10.8X. This frequency agrees with the theoretical IRBP defect frequency for the high-speed downwind radial

bearing. A series of 1X sidebands are present on both sides of the central fault frequency line. (Most often, sidebands occur in spectra because of amplitude modulation of vibration happening at the center frequency.) The IRBP frequency at 10.8X is close to a harmonic of HSS speed at 11.0X, so at first glance, all the lines in the spectrum appear to be equally spaced harmonics of 1X. Close inspection shows that there really are two distinct harmonic series, one series based on 1X, and the other based on 1X sidebands from 10.8X. You can clearly see that the two families of spectral lines nearly overlap, and that separation is visible in the split lines near 5X and 6X.

The very rich spectrum occurs because of the extremely sharp impulses in the original waveform in Figure 2. The theoretical spectrum of a single, sharp, periodic impulse is an infinite harmonic series of narrow lines starting at the fundamental repeat frequency. In this case, we have a more complicated repetition pattern, but the sharp nature of the repeating impulses produce a similar effect in the envelope spectrum.

There are two sources of amplitude modulation in the waveform. The 10.8X line is obviously related to the inner race defect. This defect causes amplitude modulation of the waveform at the element pass period (the relatively small impulse spacing in Figure 2). The 1X line is caused by relatively large scale amplitude modulation as the inner race rotates in and out of the load zone. Both

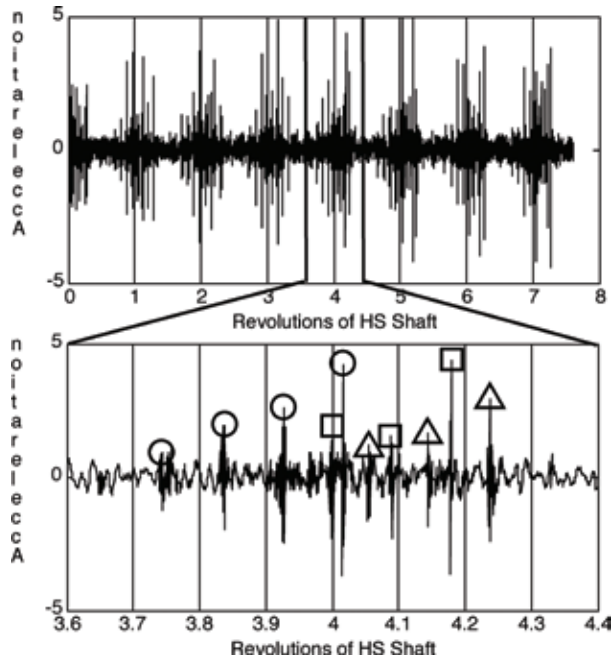
Figure 8: HSS accelerometer waveform from the second turbine gearbox. The circular, square, and triangular marks highlight three distinct patterns of fault induced impulses. This pattern suggests at least three separate inner race faults.

The impulses appear to form three distinct repeating groups (these are marked in the lower figure with circles, squares, and triangles); in each group, impulses are separated by the IRBP fault period ( $1/10.8X = 0.093$  revolutions) for the HSS downwind radial bearing. All of the impulses disappear and reappear once per

In April 2010, another turbine was commissioned. This turbine was identical in every way to the first one. The HSS accelerometer data showed similar behavior to the first turbine (Figure 8, upper). This waveform shows a similar, very complex series of very narrow impulses.

revolution of the high-speed shaft. We concluded that at least three different faults on the inner race of the bearing were repeatedly passing through the bearing load zone. Note that the impulse amplitudes are also 4 to 5 g. Because there were so many indications of damage, we felt that there was a very good chance that this bearing would have visible damage that could confirm the diagnosis. This bearing is located in an accessible part of the gearbox, so the operator decided to replace this bearing, work that could be done up tower without a crane.
